# Closer Look Property Inspections Inc

## Property Inspection Report

Property address: **145-11 Some Where Street  
Springfield Gardens, New York**

Inspection date: **8/17/2010**

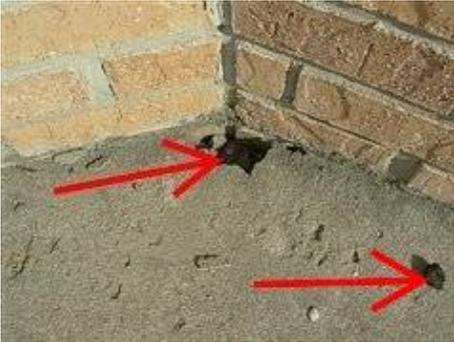
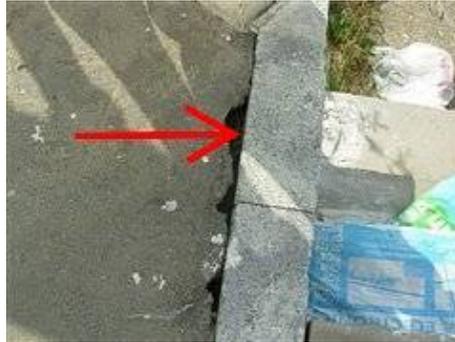
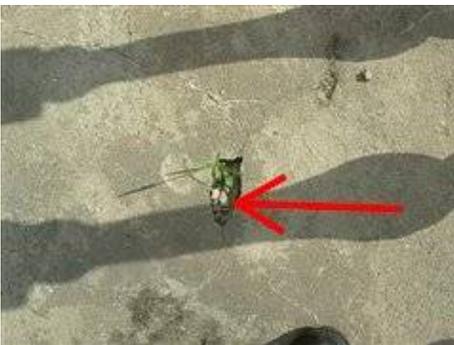
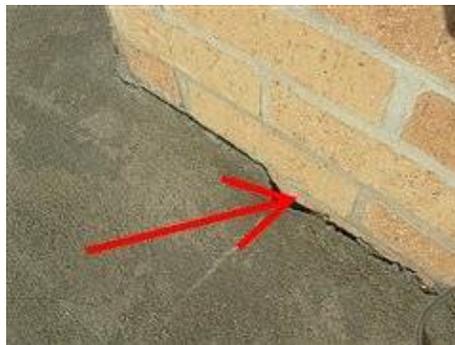
The porch has holes and cracks that should be sealed to prevent rain water and wood destroying insects from entering. It appears the foundation for the cement is substandard. Recommend a qualified contract repair or replace if needed.

Photo 1  
Holes on front

Photo 11  
Holes in front

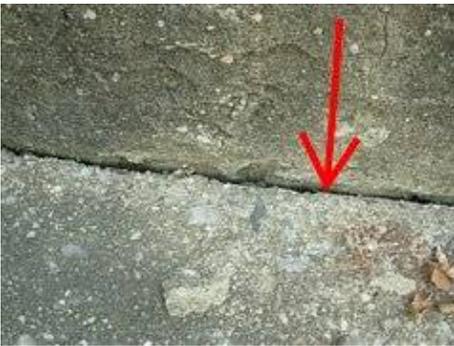
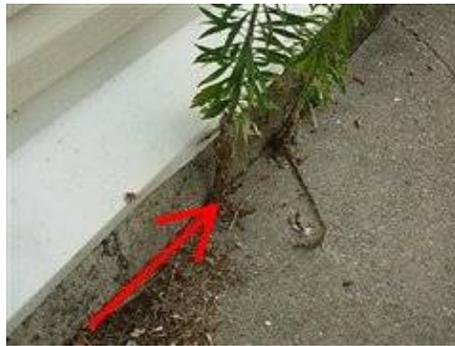
Recommend sealing the gaps between the structure and ground to prevent rain water, moisture and wood destroying insects from entering the structure. Weeds are now growing in these areas and should be removed as it will retain moisture which could cause mold growth.

Photo 36  
Seal spaces between ground and foundation wall

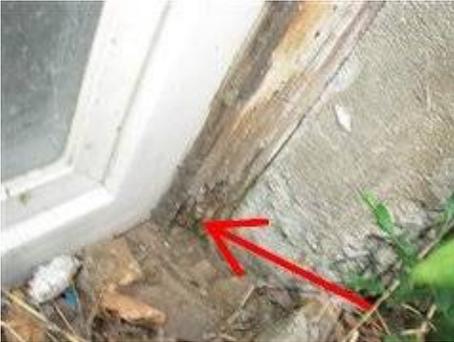
7) 🪛💧 The basement window frame on the north side has some carpenter ant damage. Recommend replacing the frames and treating the house for carpenter ants.

Photo 9  
Carpenter ant damage

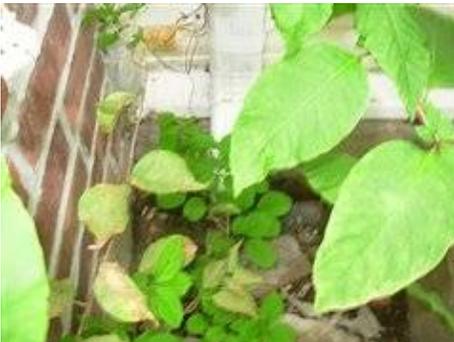
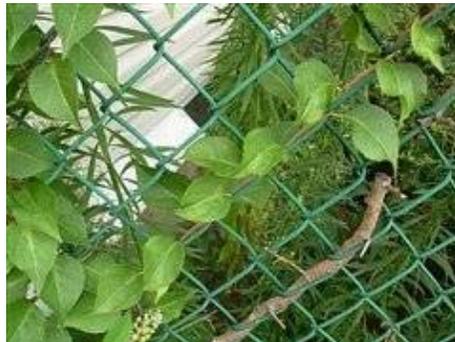
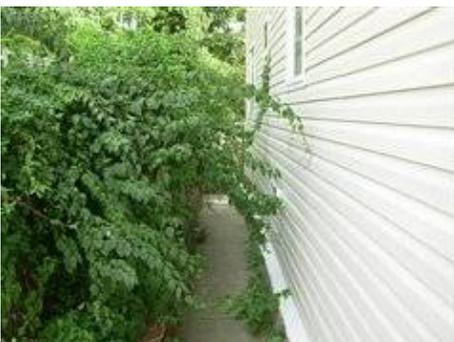
8) 🪛💧 Vegetation such as shrubs and vines was in contact with or less than one foot from the building exterior. Vegetation can serve as a conduit for wood destroying insects and may retain moisture against the exterior after it rains. Vegetation should be pruned and/or removed as necessary to maintain a one foot clearance between it and the building exterior.

Photo 3  
Vegetation on structure

Photo 8  
Vegetation in contact with structure

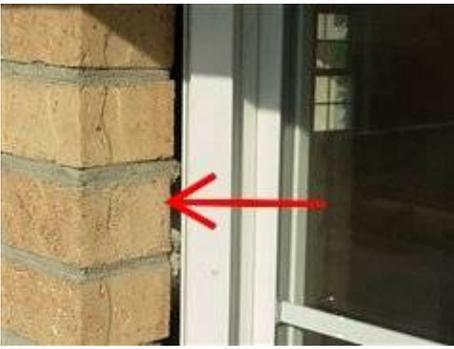
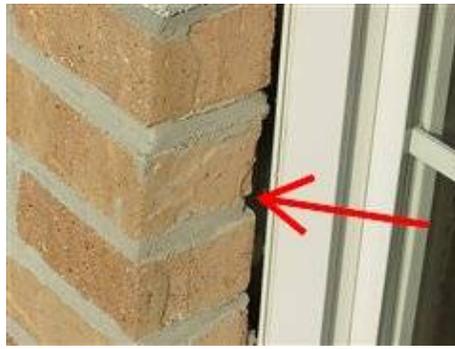
The windows in the front has wide gaps and no insulation. The windows appear to be too small and not screwed into the window frame. Rain water and moisture as well as wood destroying insects can cause damage if not corrected. This condition can also cause mold and heat loss. Recommend a qualified contractor repair as needed.

Photo 22  
Large gaps at front window

Photo 23  
Large gaps at front window

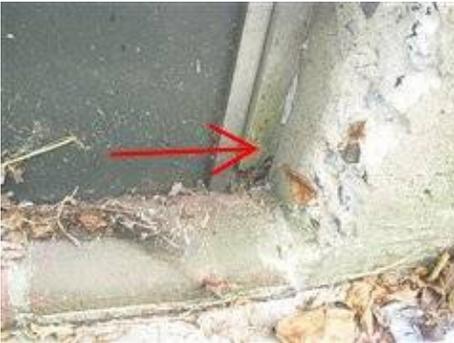
Rot or water damage was found at one or more sections of window frames. A qualified person should evaluate and repair as necessary. All rotten wood should be replaced.

Photo 2  
replace basement windows

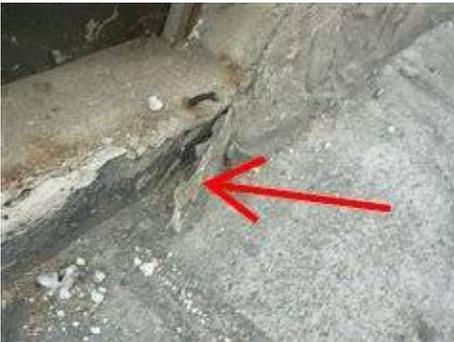
Cracks, and damage were found in some areas of the stucco siding on the south side rear . A qualified contractor should evaluate and make repairs and/or replace stucco siding as necessary.

Photo 10  
Damaged Stucco

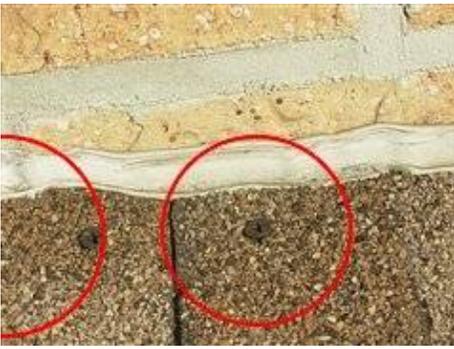
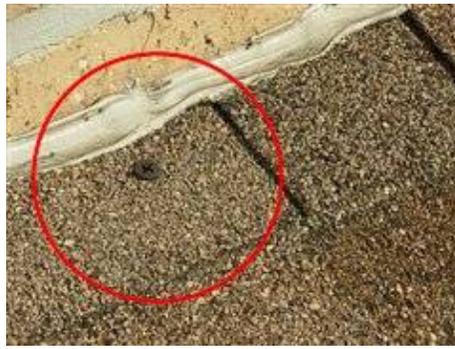
The shingle covering over the front bay window are installed with dry wall screws. Dry wall screws are not intended for this use and is a potential leak area. Recommend a qualified roofing contractor install the proper nails to prevent any leaks.

Photo 24  
Dry wall screws installed on roof shingles

Photo 25  
Dry wall screws installed on roof shingles

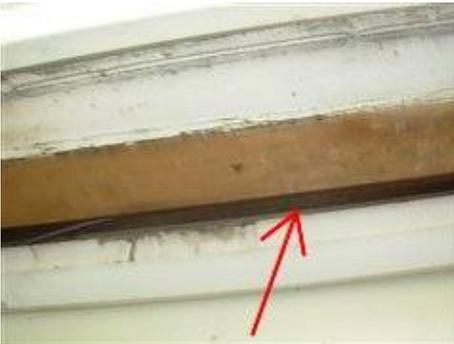
- 
- 14) 🛠️ 💧 The frame around the bay windows are not capped and caulked which can attract moisture and wood destroying insects.

Photo 7  
Gap at front window and missing cap

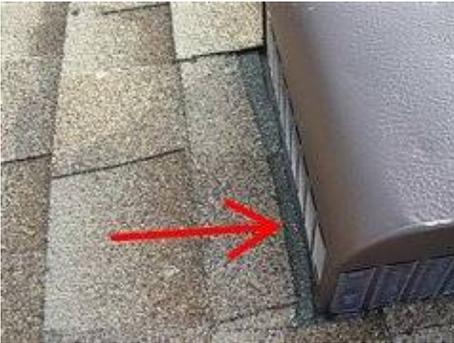
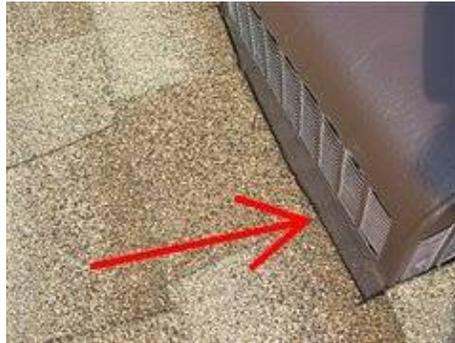
Many roof flashing were missing. Leaks may occur as a result. A qualified contractor should evaluate and repair as necessary.

Photo 15  
Flashing should be installed over shingles

Photo 20  
Flashing should be installed over shingles

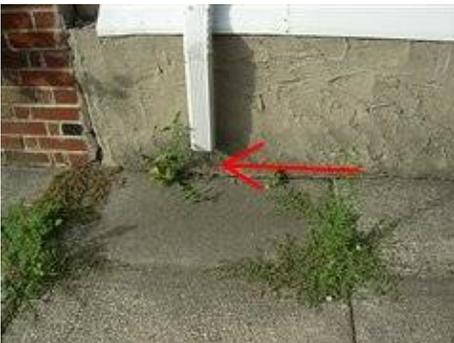
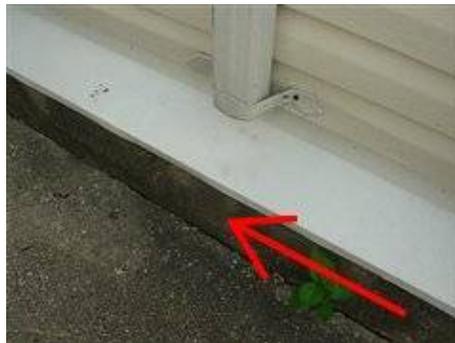
Extensions such as splash blocks or drain pipes for all downspouts were missing. Water may accumulate around the building foundation as a result. A qualified person should evaluate and repair, replace or install as necessary

Photo 13  
Downspout extension needed

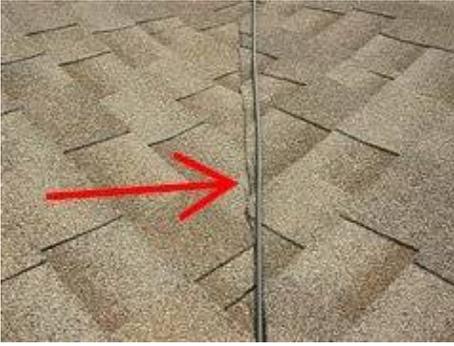
It appears that there are no valley flashing installed. Valley flashing are effective in draining rain water

into the gutters. This is a potential leak area and should be monitored. Recommend that a roof contractor install a metal valley flashing.

Photo 21  
Valley flashing needed

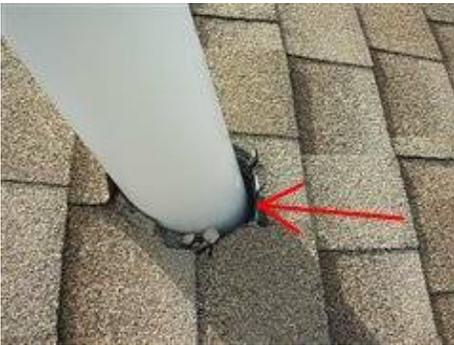
The exhaust PVC pipe does not have a boot flashing installed. Rain water is entering this area and can cause serious interior damage. It is also a conducive condition for wood destroying insects. Recommend a roof contractor install a boot flashing to cover the existing opening and keep rain water from entering the structure.

Photo 14  
Boot flashing needed

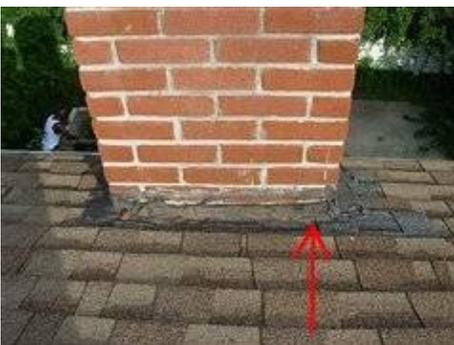
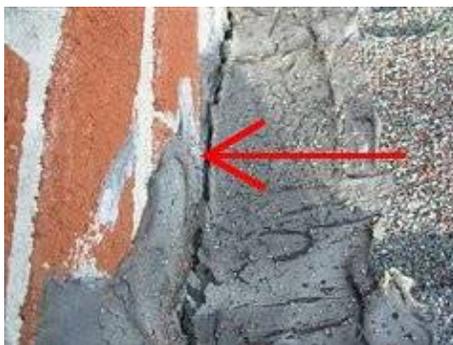
The chimney does not have a step flashing and counter flashing installed. These flashing are needed to keep rain water and moisture from entering the structure. The bedroom closet on the second floor shows a wet stain on the ceiling close to the chimney area. It may be leaking as a result of the missing flashing. Recommend a roof contractor install the step and counter flashing as needed.

Photo 17  
Counter & Step flashing needed

Photo 19  
Counter & Step flashing needed.

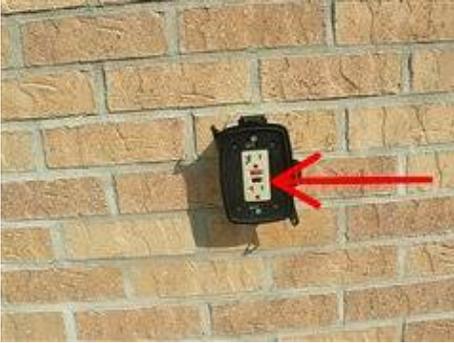
The G.F.C.I receptacles on the exterior needs a weather protected cover to prevent water and moisture from entering. The receptacle in the front has no power. Recommend a licensed electrical contractor evaluate and repair as needed.

Photo 29  
Exterior outlet needs cover

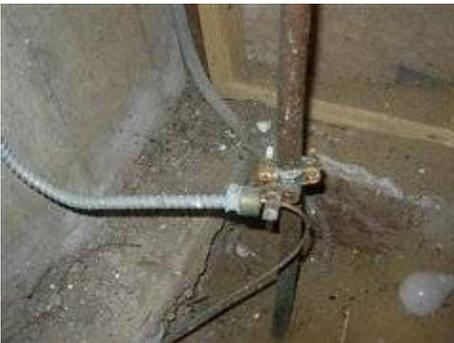
Both the ground driven rod and the cold water ground is currently connected to the same grounding conductor. They both should have separate conductors which is number six grounding conductor connected to the main service panel. Recommend a qualified electrical contractor evaluate and make the proper connections as needed.

Photo 38  
Cold water grounding conductor  
connected to ground rod

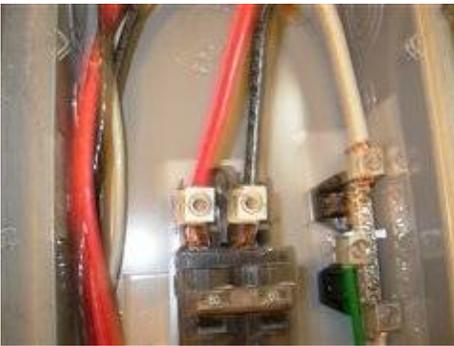
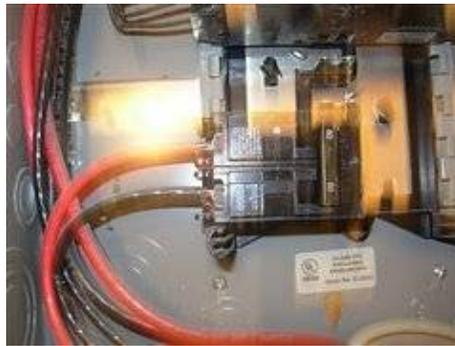
27) It appears the sub panel in the basement may have over sized cables installed in the 60 amp breaker. Recommend further evaluation from a electrical contractor and replace if needed.

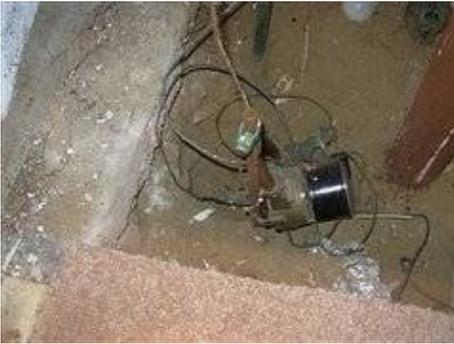
The water meter box was damaged. A qualified person should repair as necessary. The water meter was not connected. Recommend a qualified plumber install and repair as needed.

Photo 30  
Water meter not installed

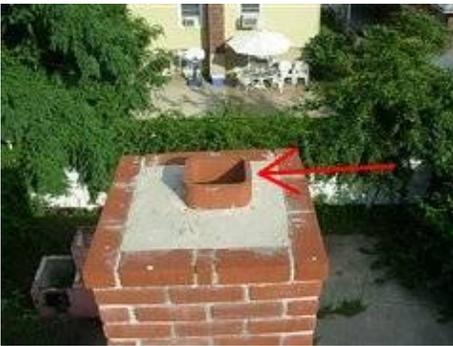
Recommend installing a chimney cap which will help prevent the interior flue from damage due to the gases and water mixing.

Photo 16  
Chimney cap needed

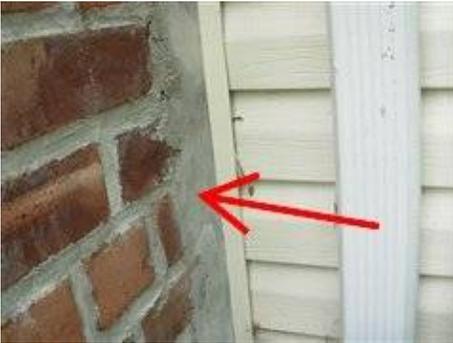
The exterior of the chimney is heavily covered with cement in many areas. Recommend asking the owners about this to determine if the repairs were made by a licensed contractor. The upper portion of the chimney is new, it is strongly recommended that a chimney company inspect the interior as well as the exterior to determine if the chimney is in good condition.

Photo 4  
Heavily cemented chimney

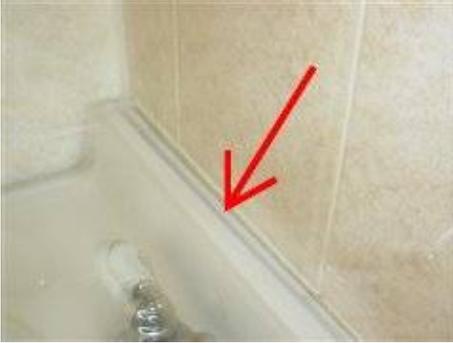
Photo 27

Caulk was missing around the sink at location #B. A qualified person should repair as necessary.

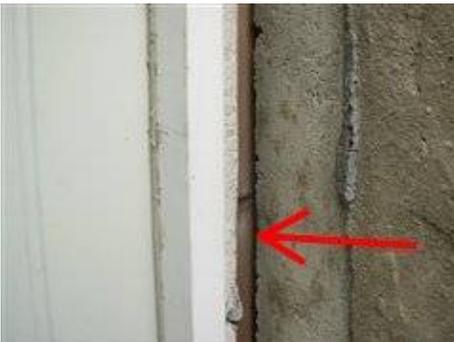
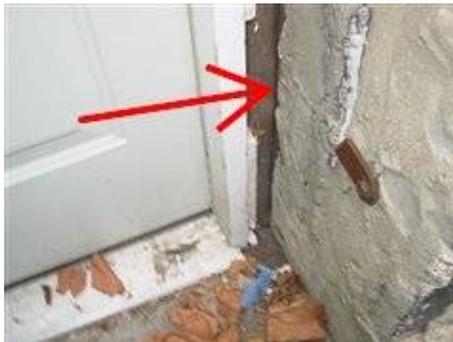
Trim or jambs around one or more exterior doors was missing in the basement rear door. A qualified person should repair, replace or install as necessary.

Photo 5  
Gaps between door jamb

Photo 6  
Gaps between door jamb

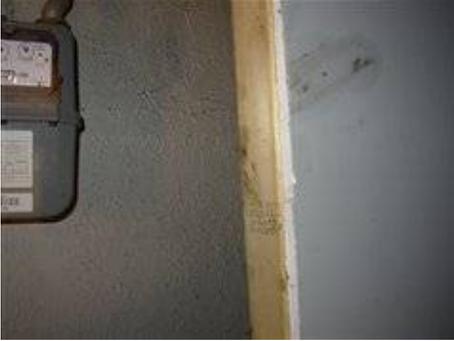
Photo 31

43) The foundation walls in the basement could not be evaluated due to dry wall installation. The foundation wall is excluded from the inspection.

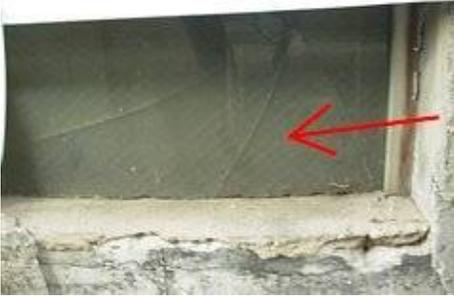
Photo 12  
Cracked basement window

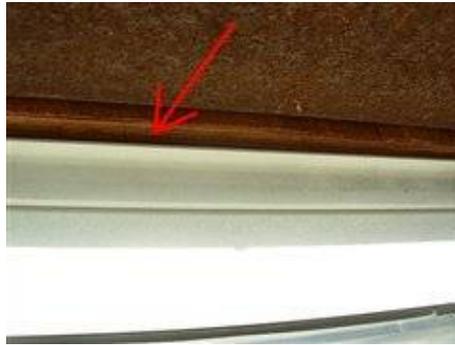
Photo 28  
Space over front window needs to be capped
